# **ARB** **FITTING INSTRUCTIONS**

## **HILUX SR5 'A' DECK TAIL GATE LIFT ASSIST KIT 4714010**

**KIT: 6177285**

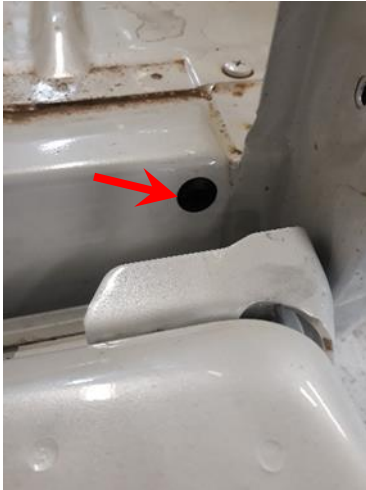
- 1.1 Open the tailgate. Remove and discard the rubber bung on the body of the tub near the RH Hinge.

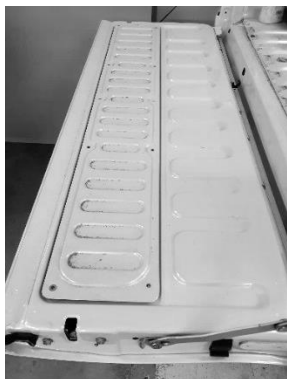
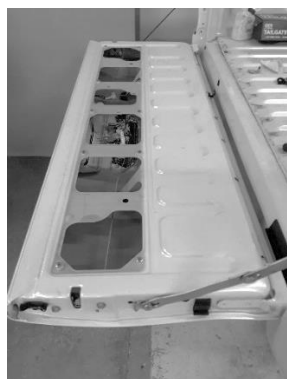
1.7 Affix the Bracket to the tub using the 6151882 M8 Ultra Thin Head Screw through the aligned holes from the tailgate side. From the underside of the tub, use the 3195116 Back Plate, M8 Washer and Nyloc as shown.

**Do not fully tighten the screw & nut at this stage.**

- 1.21 Tail gate in lowered position: Tighten the 6151882 M8 Ultra Thin Head Screw & M8 Nyloc nut which was left loose on step 1.7. **Torque to 10Nm.**

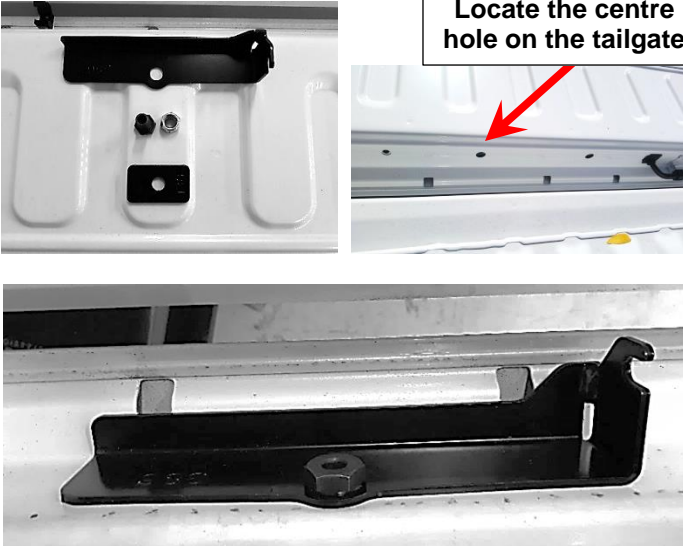
<p><b>Locate the centre hole on the tailgate</b></p>

<p><b>Back Plate and Nut as viewed from inside the tailgate</b></p>	<p>1.9 Locate the lower centre hole of the tailgate. From the outside, insert the 6365071 Threaded Bush through 3750386 Bracket and the tailgate hole and position the Bracket.</p> <p>1.10 From inside the tailgate, (through the inspection panel opening), locate the previously inserted threaded bush and align the 3195138 Back Plate and M12 Nyloc nut into position and <b><u>tighten to 10Nm</u></b></p> <p><b>DO NOT reattach the inspection panel at this stage.</b></p>

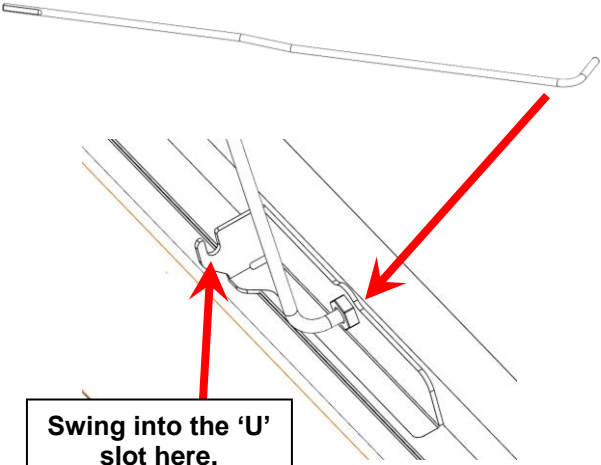
<p><b>Swing into the 'U' slot here.</b></p>	<p>1.11 Taking the bent end of the Torsion Spring, feed it into the Threaded Bush and swing it into the 'U' slot of the Bracket.</p>

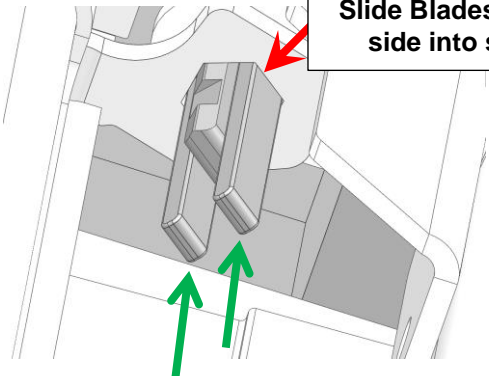
<p><b>Slide Blades either side into slots</b></p>	<p>1.12 Slide in the 3193801 support blades through the hex bracket above the large flat surfaces of the Hex Bolt. (Blades should hold in position)</p>

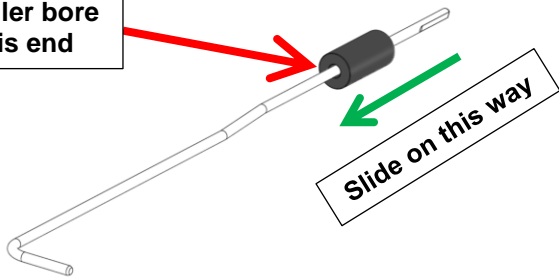
</div>	<div>Note:-</div> <div>The kit will contain one of the following sleeves:-</div> <div><ul style="list-style-type: none"><li>• 6364514 (Threaded Hole near <b>SMALLER</b> diameter bore) Or</li><li>• 6364515 (Threaded hole near <b>LARGER</b> diameter bore)</li></ul></div>	
<div><div>Smaller bore This end</div><div>

</div></div>			<div>1.13</div> <div>At the free end of the Torsion Spring, place the sleeve over the Spring. (Insert the sleeve through the smaller bore into the Torsion Spring.)</div>
<div><div>

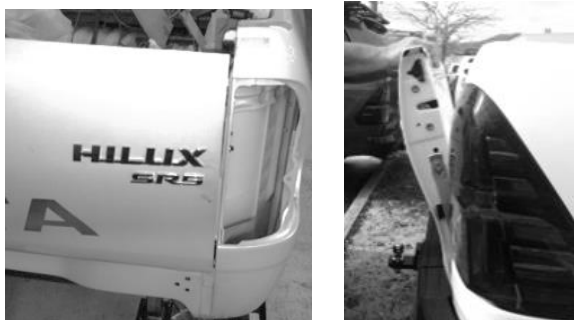
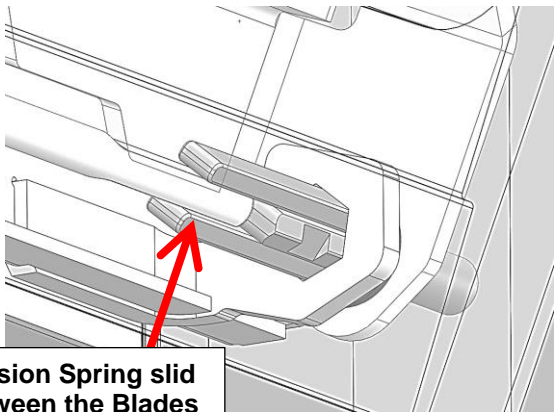
</div><div>Tailgate opened approx. 30°</div><div>

</div><div>Torsion Spring slid between the Blades</div></div>			<div>1.14</div> <div>Swing the tailgate to approximately 30° from the closed position and support.</div> <div>1.15</div> <div>Hold the Blades in position and from below the tailgate, slide the flat section of the torsion spring in between blades. (you may need to adjust the tailgate position to ensure clean alignment.)</div>

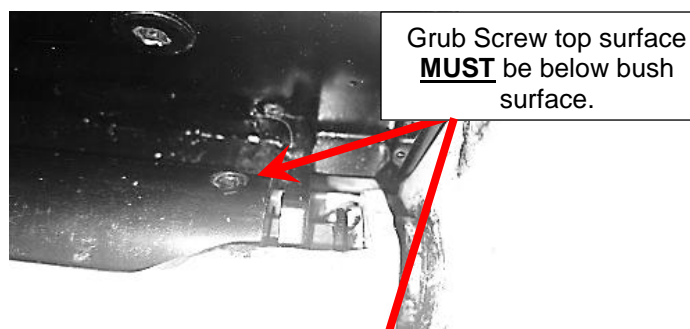
Grub Screw aligned to Hex Stud and Below surface of Sleeve

- 1.18 Align the Grub Screw hole to the upper ridge on the Hex Stud and screw the Grub Screw down to **6Nm** onto the machined flat slot of the Hex Stud. Check that the Grub Screw top surface is below the Sleeve outer surface when tightened. If it is not, slightly rotate bush and re-tighten so the Grub Screw's top surface is below the Sleeve surface. Ensure the Sleeve is secured by trying to move or rotate it. When the Grub Screw is properly positioned and tightened fully to 6Nm the Sleeve will not move in any direction.

**If the Grub Screw is not tightened correctly into the groove, the Sleeve may become loose and allow it to slide off the Hex Stud and dislodge the Torsion Spring. Damage or injury may result if not correctly tightened.**

**If the top of the Grub Screw sits above the surface of the Sleeve, it indicates that the Grub Screw is not positioned correctly. Loosen the screw slightly and with the tailgate held ajar, rotate the Sleeve slightly so the Grub Screw and Hexagonal ridge are aligned. Repeat tightening procedure.**

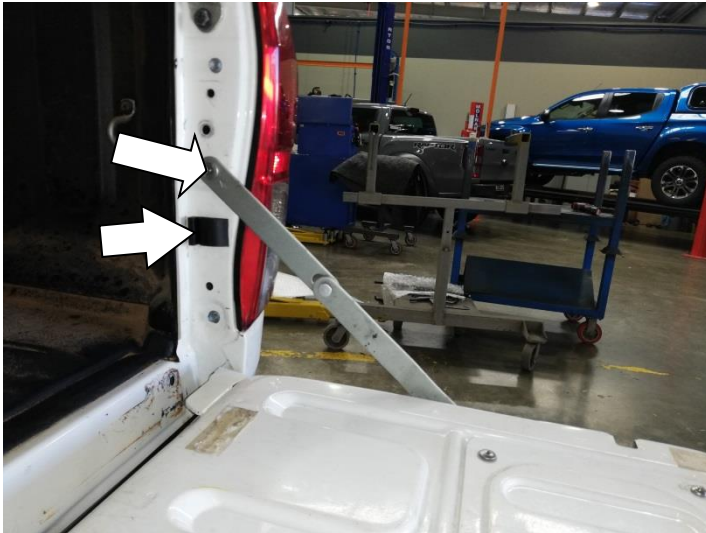
2.1 Undo the 2 screws (1 screw on the body & 1 on the tailgate) holding the limiting strap on RH side.

2.2 Remove the straps, washer & strap guide bracket (on the tailgate) and discard all items.

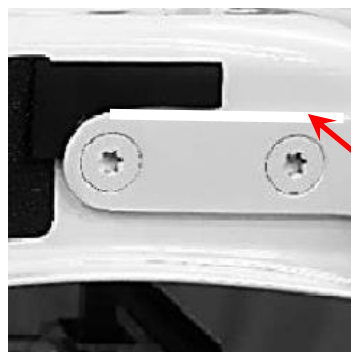
Blackout Patch

Clear Sticker

**!**  
**Ensure the Edge of the clear sticker is below the edge surface of the tailgate Hinge Bracket or this will cause the cable to catch in closing**

- 2.7 Using an alcohol wipe, clean all areas along the side of tailgate where the 2125739R Blackout Patch, 2125755R Slip Pad and 2125725 Clear Sticker are to be used. Clean for both sides of the tailgate
- 2.8 Attach the Slip Pad first and then the blackout Sticker in position as shown, making sure to cover all holes and keep even to the line of tailgate

**These items are necessary to protect surfaces and allow the cable to ride over the tailgate hinge without damaging the cable or mating parts.**

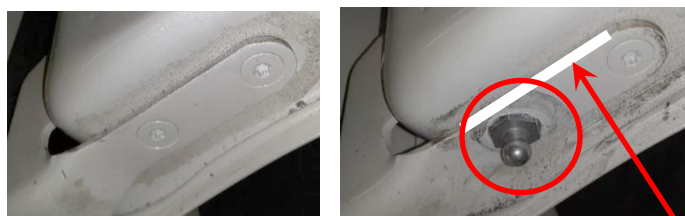
**! Ensure the Edge of the clear sticker is below the edge surface of the tailgate Hinge Bracket or this will cause the cable to catch in closing**

- 4.2 On the tailgate, remove the countersunk hinge screw nearest where the tailgate mounts to the vehicle and replace with the 6151908 Countersunk Ball Stud.

Tighten the Ball Stud **to 22Nm**

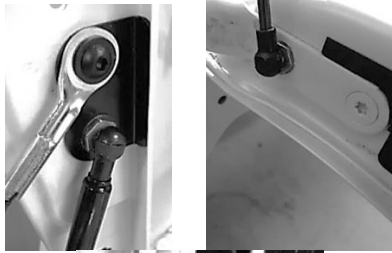
- 4.4 Fit the 4590031 Damper with the Rod end of the Damper clipped to the ball stud fitted to the tailgate.
- 4.5 Fit the cylinder end of the Damper into the to the ball stud on the LH side of the vehicle tub.
- 4.6 Operate the tailgate 5 times to make sure the action is opening and closing easily.

**Check the cable strap is sitting under the lower end of the Damper and to the tailgate side when the tailgate is closed**
